Title: Product wind resistance, dynamic water tightness and impact resistance testing of a rainscreen panel assembly for Architectural Profiles Limited

Report No: N950-21-18153

Issue date: 22 September 2021

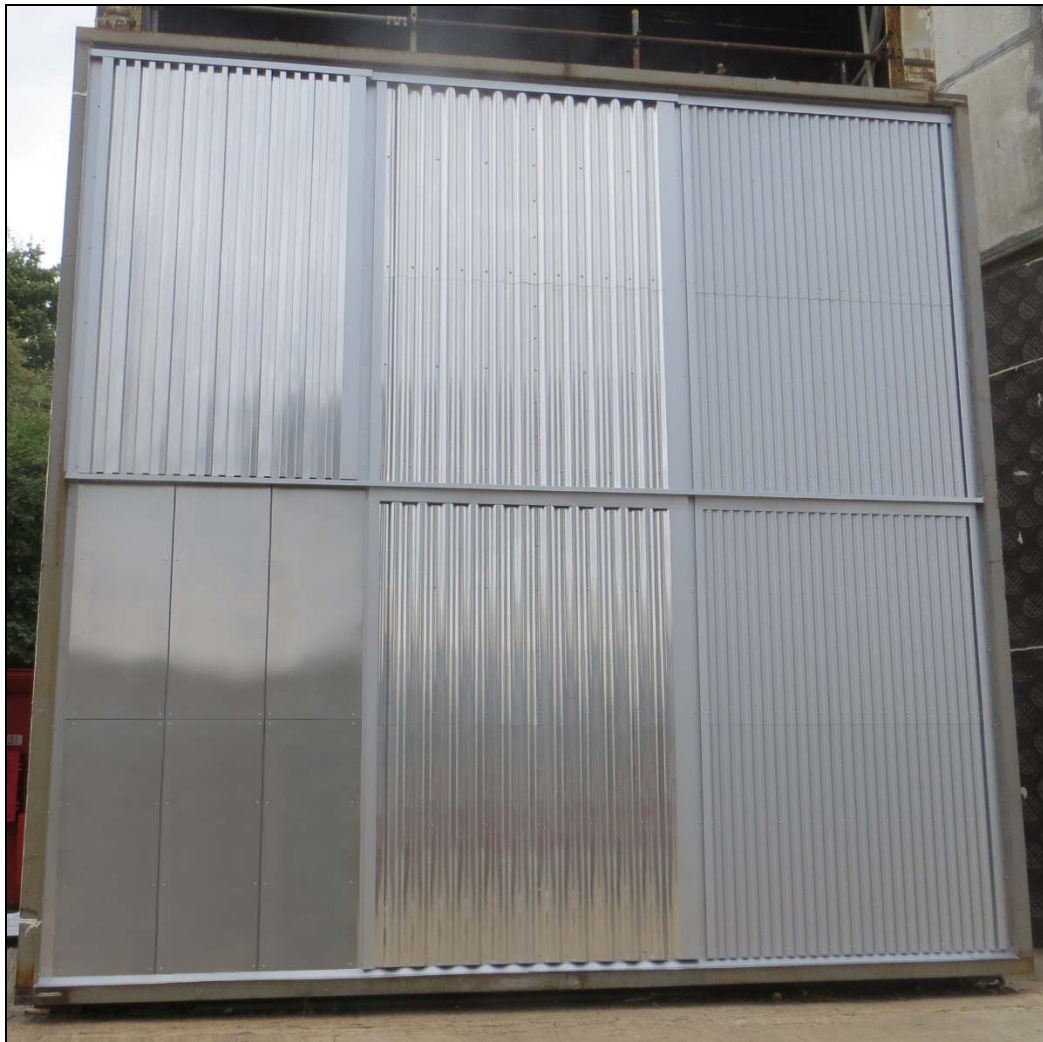
PHOTO 1759

The sample was as shown in the photo below and the drawings included as an appendix to this report.

The test sample measured 6.0 m high by 6.0 m wide.

The sample was mounted on a backing wall supplied by Technology Centre, comprising of 100 x 100 mm angle and 19 mm plywood boards.

TEST SAMPLE ELEVATION

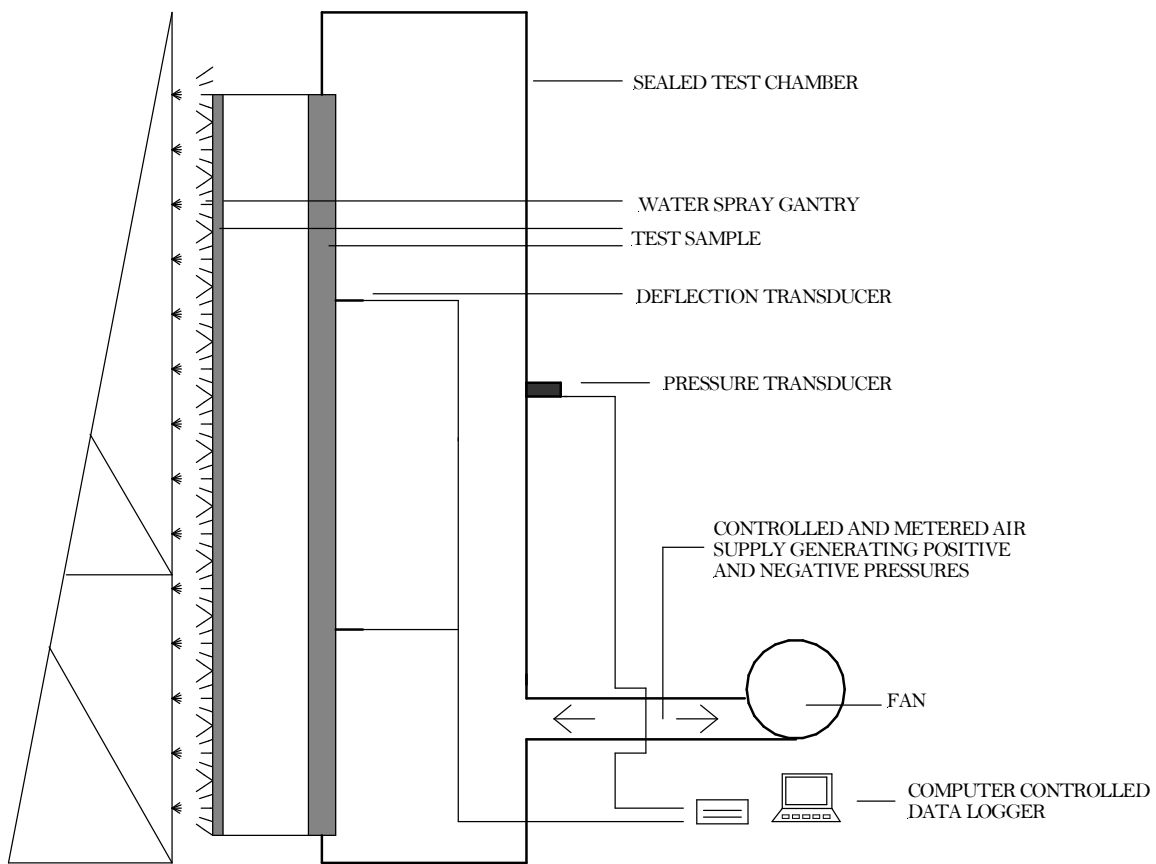
FIGURE 1

The test sample was mounted on a rigid test rig with support steelwork designed to simulate the on-site/project conditions. The test rig comprised a well sealed chamber, fabricated from steel and plywood. A door was provided to allow access to the chamber. Representatives of Architectural Profiles Ltd installed the sample on the test rig. See Figure 1.

TEST RIG SCHEMATIC ARRANGEMENT

SECTION THROUGH TEST RIG

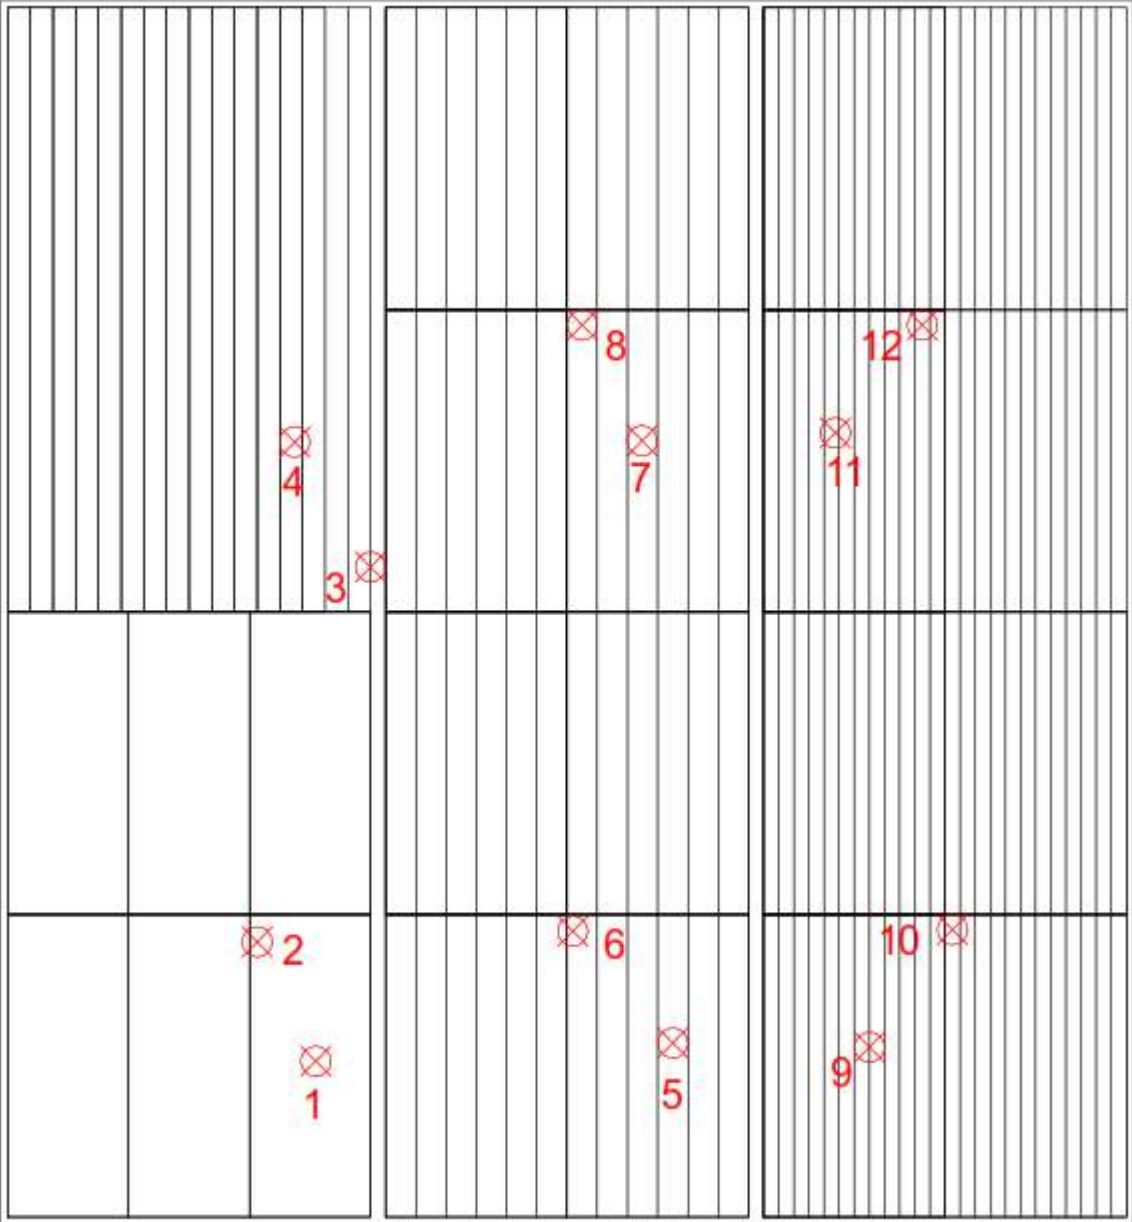
FIGURE 2

Displacement transducers were used to measure the deflection of principle framing members to an accuracy of 0.1 mm. The gauges were set normal to the sample framework at mid-span and as near to the supports of the members as possible and installed in such a way that the measurements were not influenced by the application of pressure or other loading to the sample. The gauges were located at the positions shown in Figure 2.

DEFLECTION GAUGE LOCATIONS

Deflection gauge

The deflections measured during the wind resistance test, at the positions shown in Figure 2, are shown in Tables 5 and 6.

The deflections measured during the structural safety test, at the positions shown in Figure 2, are shown in Table 7.

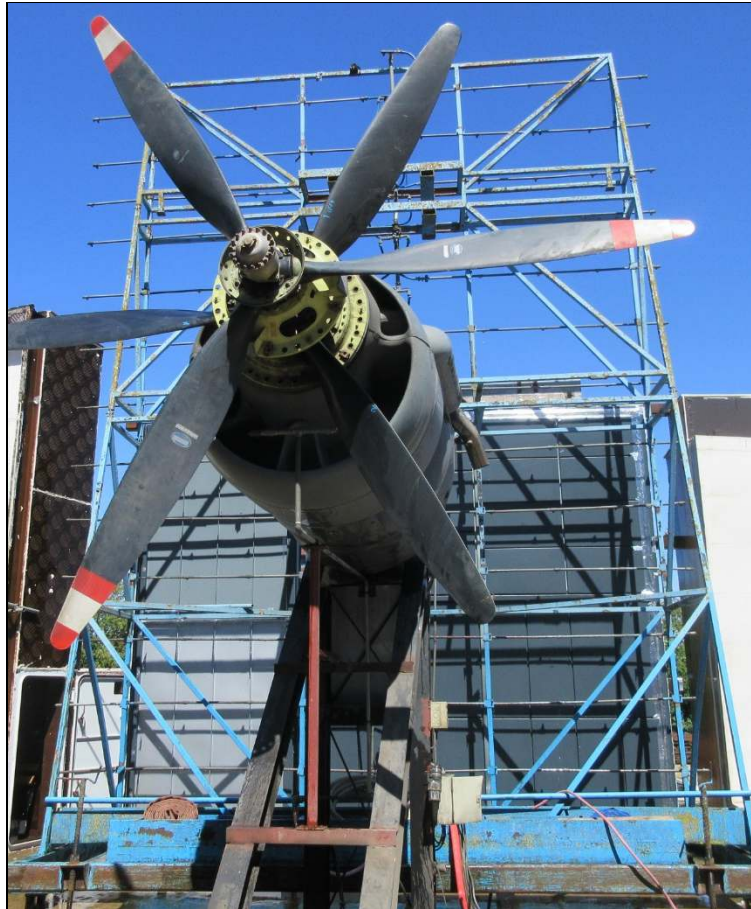
A wind generator was mounted adjacent to the external face of the sample and used to create positive pressure differentials during dynamic testing. The wind generator comprised a piston type aero-engine fitted with 4 m diameter contra-rotating propellers.

DYNAMIC WIND GENERATOR

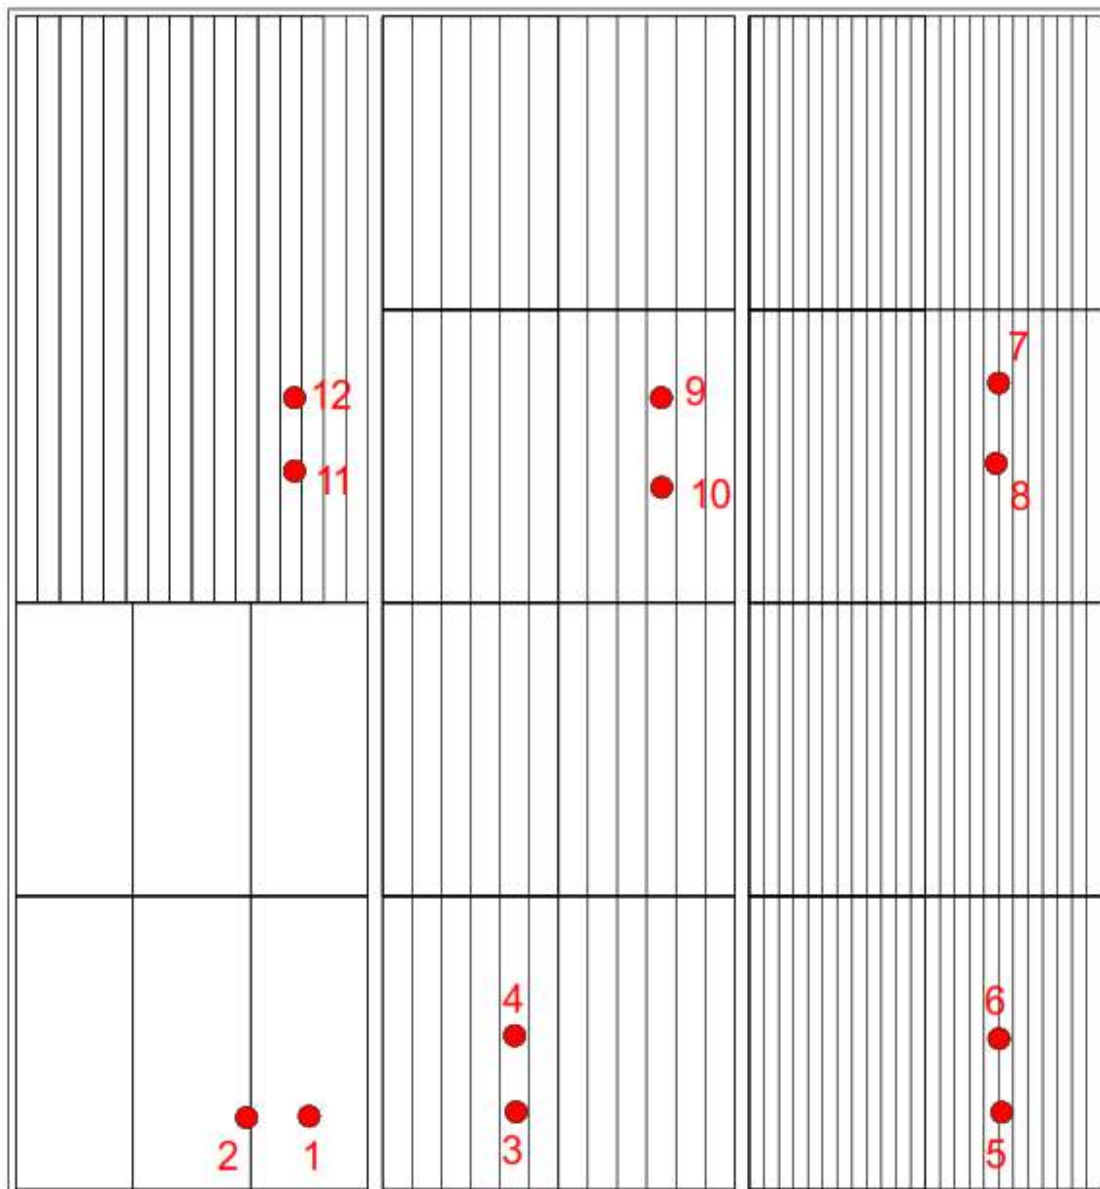
FIGURE 3

The impactor almost touched the face of the sample when at rest. It was swung in a pendular movement to hit the sample normal to its face. The test was performed at the locations shown in Figure 3. The impact energies were 120 J for serviceability and 350 J and 500 J for safety.

The impactor almost touched the face of the sample when at rest. It was swung in a pendular movement to hit the sample normal to its face. The test was performed at the locations shown in Figure 3. The impact energies were 3 J, 6 J and 10 J.

IMPACT TEST LOCATIONS

● Impact location

Impact location	Impact energy (Nm)	Observations	Classification
1	120 x 3 350 500	No damage observed 2 mm deformation 5 mm deformation	Class 1 Negligible risk Negligible risk
2	120 x 3 350 500	No damage observed No damage observed No damage observed	Class 1 Negligible risk Negligible risk
3	120 x 3 350 500	No damage observed Large deformation Large deformation	Class 1 Negligible risk Negligible risk
4	120 x 3 350 500	Small crease at panel fixings Minor crumpling Further crumpling	Class 2 Negligible risk Negligible risk
5	120 x 3 350 500	Small crease at panel fixings Minor crumpling Further crumpling	Class 2 Negligible risk Negligible risk
6	120 x 3 350 500	Small crease at panel fixings Minor crumpling Further crumpling	Class 2 Negligible risk Negligible risk
7	120 x 3 350 500	Small crease in panel Small crease in panel Small crease in panel	Class 2 Negligible risk Negligible risk
8	120 x 3 350 500	Small crease in panel Minor crumpling Further crumpling	Class 2 Negligible risk Negligible risk

Impact location	Impact energy (Nm)	Observations	Classification
1	3 6 10	No damage Slight mark Large indent	Class 1 / Negligible risk Class 1 Class 3 / Negligible risk
2	3 6 10	Slight indent Minor indent Large indent	Class 1 / Negligible risk Class 2 Class 3 / Negligible risk
3	3 6 10	Minor indent Minor indent Large indent	Class 2 / Negligible risk Class 2 Class 3 / Negligible risk
4	3 6 10	Minor indent Minor indent Large indent	Class 2 / Negligible risk Class 2 Class 3 / Negligible risk
5	3 6 10	Minor indent Minor indent Large indent	Class 2 / Negligible risk Class 2 Class 3 / Negligible risk
6	3 6 10	Minor indent Minor indent Large indent	Class 2 / Negligible risk Class 2 Class 3 / Negligible risk
7	3 6 10	Minor indent Minor indent Large indent	Class 2 / Negligible risk Class 2 Class 3 / Negligible risk
8	3 6 10	Minor indent Minor indent Large indent	Class 2 / Negligible risk Class 2 Class 3 / Negligible risk

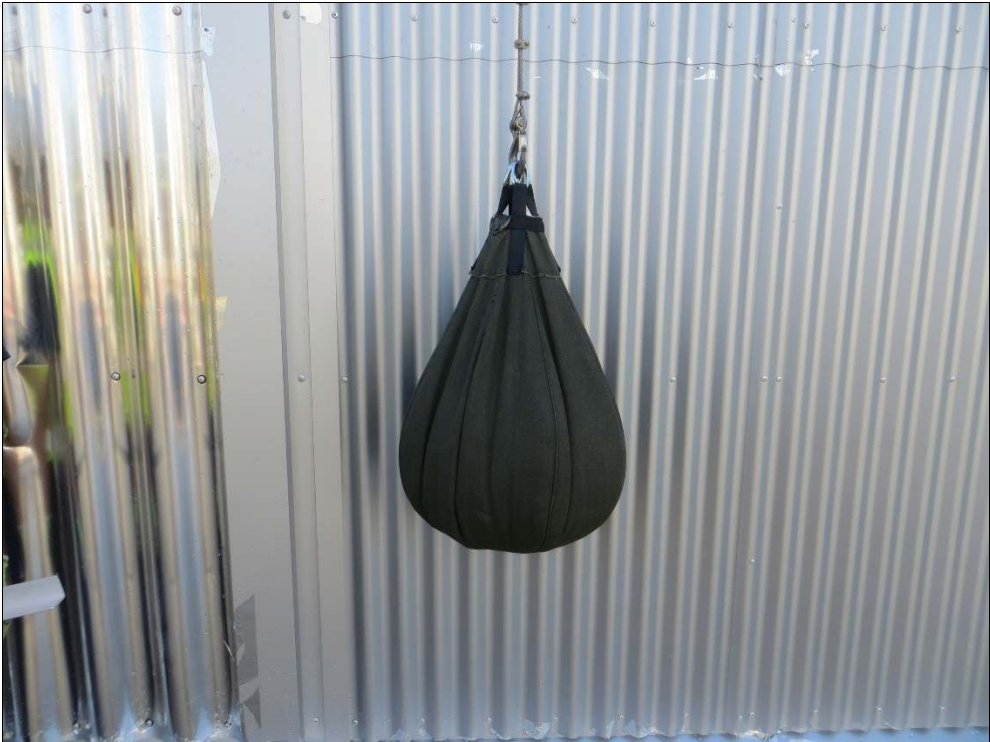
PHOTO 1923

The soft body impactor comprised a canvas spherical/conical bag 400 mm in diameter filled with 3 mm diameter glass spheres with a total mass of 50 kg suspended from a cord at least 3 m long.

SOFT BODY IMPACTOR

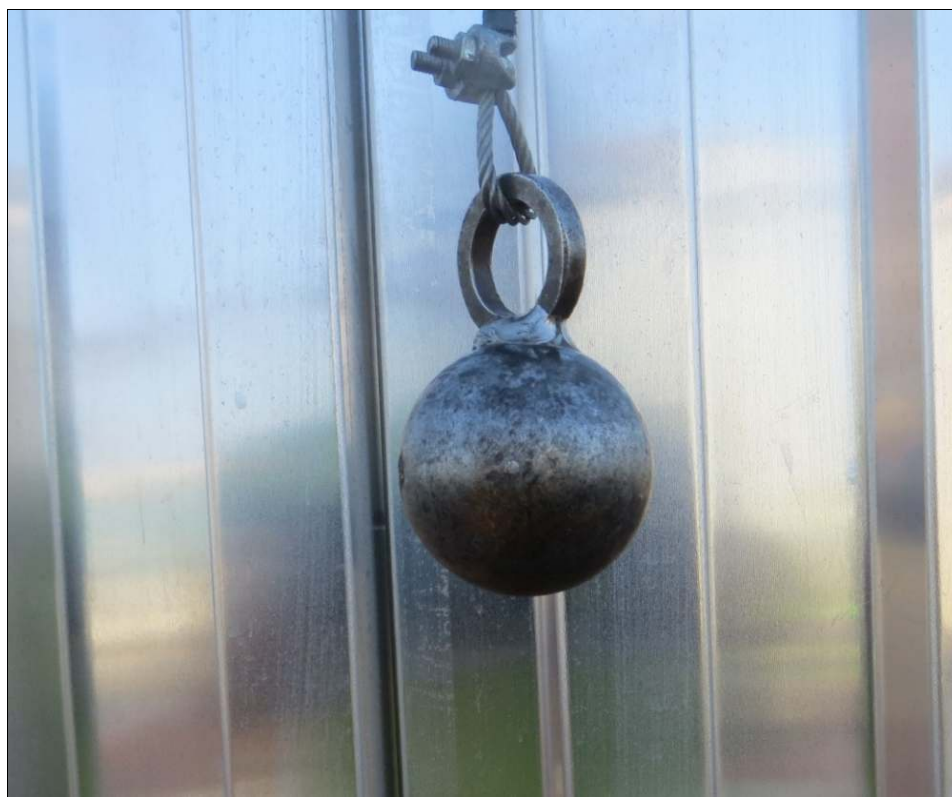
PHOTO 1958

The hard body impactor was a solid steel ball of 50 mm or 62.5 mm diameter and approximate mass of 0.5 kg or 1.0 kg.

HARD BODY IMPACTOR

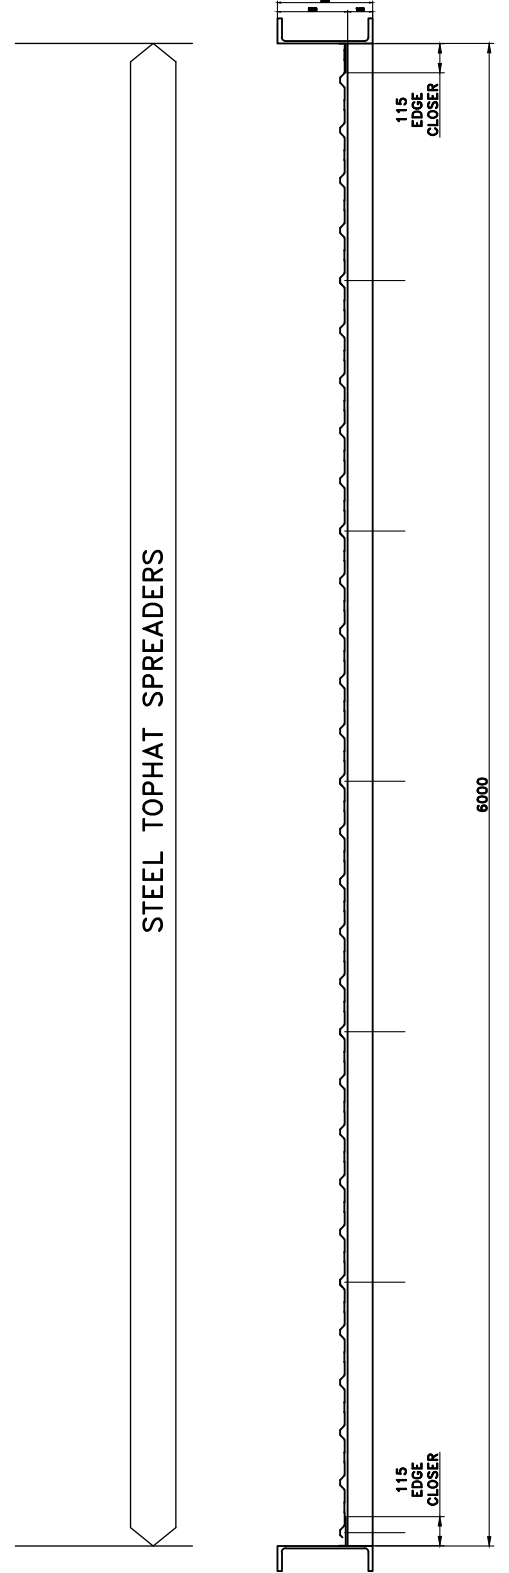
AP19LPH LINER SHEETS
 0.4MM STEEL PROFILE LINER
 FIXED AT EACH VALLEY AT ENDS
 WITH 6Ø SEAL TO CENTRE
 ENDLAP.
 SIDELAPS STITCHED AT 600mm
 CRS. and 50x1 VCT SEAL

**TEST-VINCI-2
 ELEVATION PANELS
 LINER**
TEST-VIN-2/02/c
